Case Study

Thermography prolongs motor winding life, prevents costly process failure

Mechanical Thermography

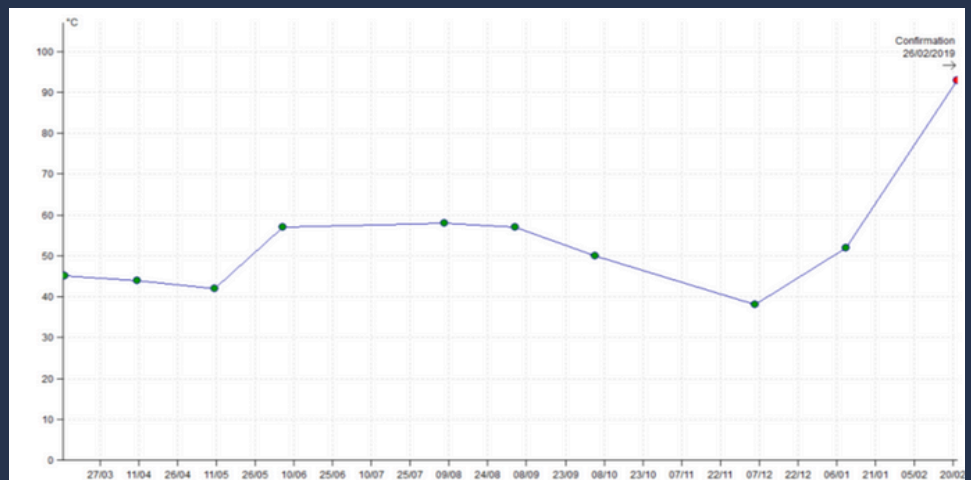
Figure 2 - Maximum motor case temperature trend for the previous 12 months

A quick check against the motor's history (Figure 2) revealed that the case temperature had not exceeded 60°C in the previous 12 months indicating that a significant change had occurred

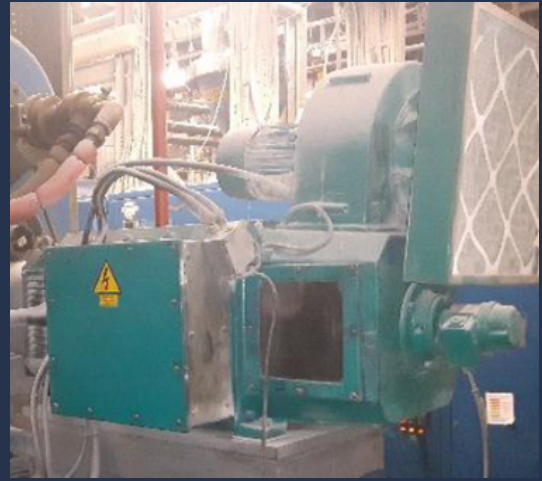
Figure 3 - DC motor with cooling fan

The discovery of the high motor case temperature prompted investigation of the asset. The large DC motor has a small AC-driven cooling fan attached to force air through the windings to provide cooling. The air enters the non-drive end of the motor after passing through an air filter (see Figure 3 adjacent) and exits at the drive end via vents.

It was noticed that the airflow out of the drive end of the motor was minimal. Further investigation found that the air filter was blocked and therefore significantly restricting the volume of air flow through the motor.

A quick scan with the thermal camera subsequently allowed the maintenance team to respond promptly and prevented damage to the motor windings and bearings.
